INDOOR AIR QUALITY ASSESSMENT

**Department of Public Works
35 Parsonage Street
Marshfield, MA**

Prepared by:
Massachusetts Department of Public Health
Bureau of Environmental Health
Indoor Air Quality Program
November 2018

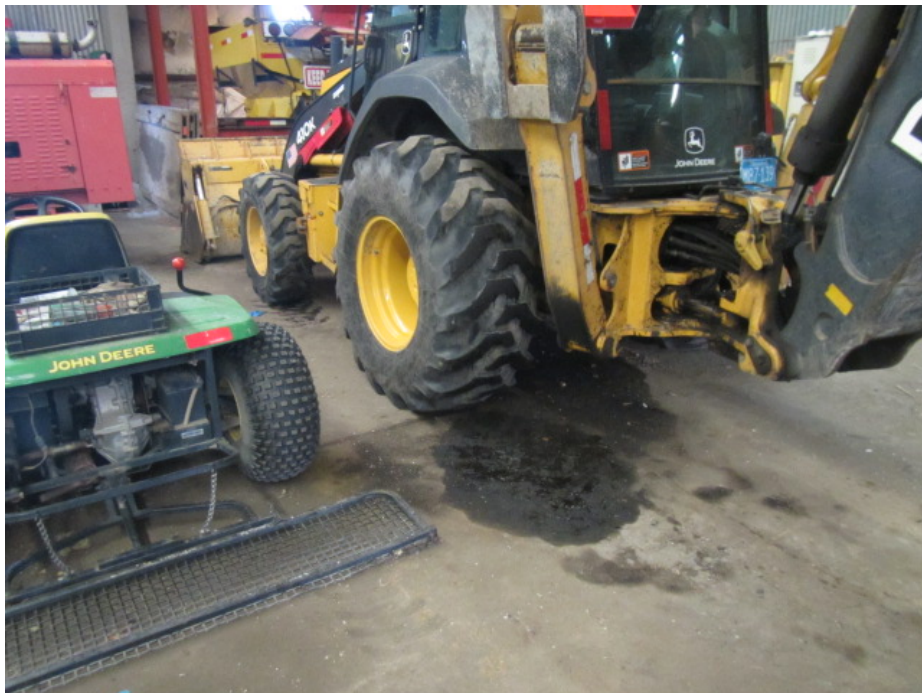
Picture 38

Vehicles and soiled concrete

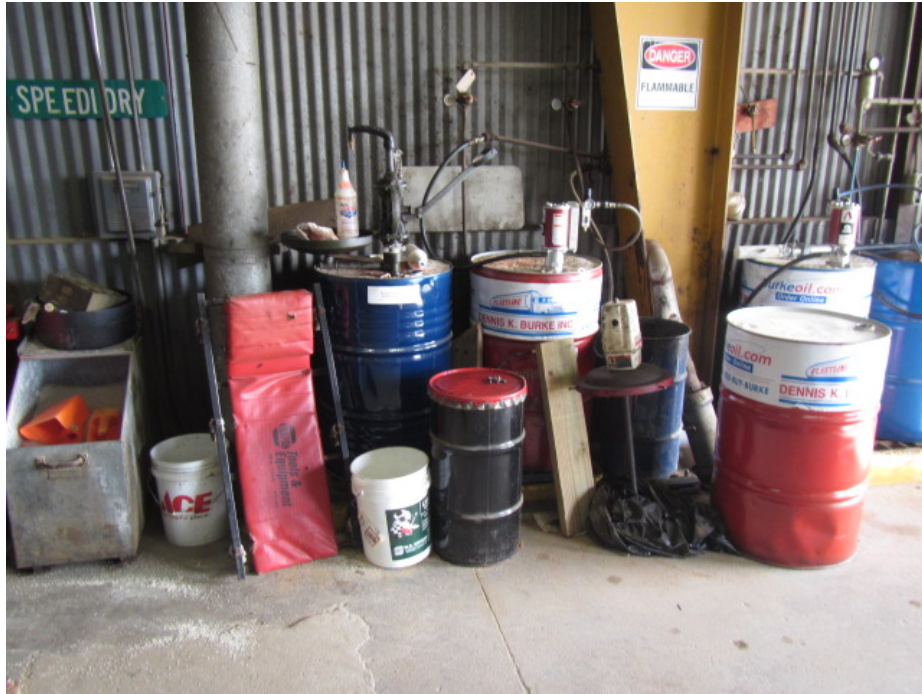
Picture 39

Chemical station/storage

14. Ensure Safety Data Sheets are available in a centralized location for any potentially hazardous products used and that staff are trained in the use of such materials, including the use of personal protective equipment when needed. Ensure good housekeeping for storage and handling of materials.

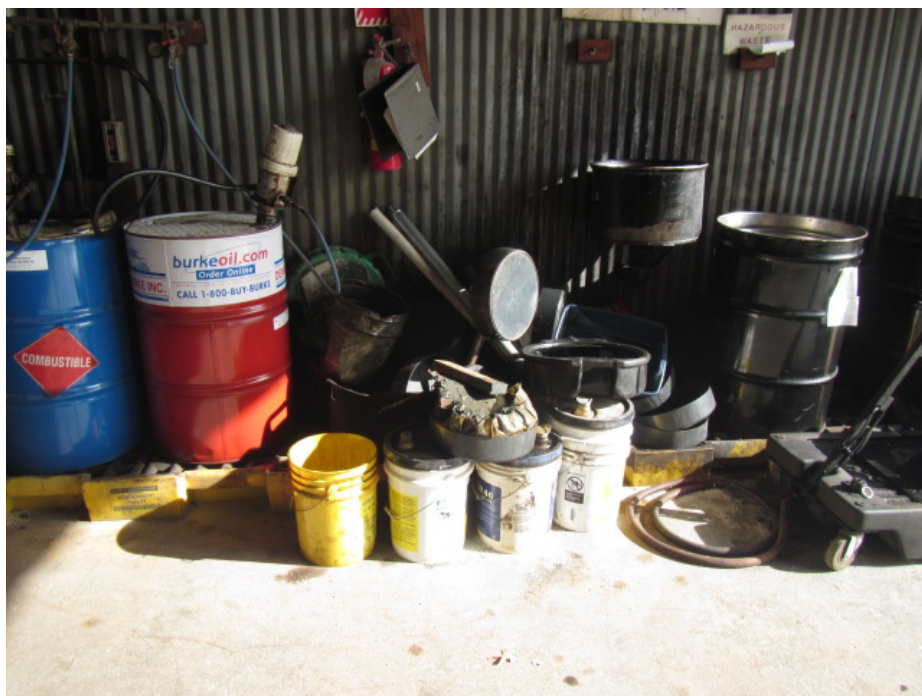
Picture 40

Chemical station/storage

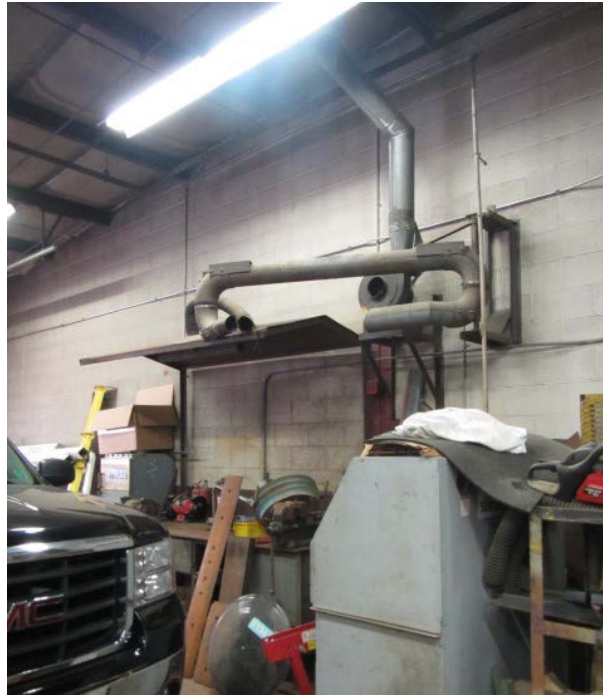
Picture 41

Abandoned/inoperable local exhaust system in welding bay

5. Provide local exhaust for fume/VOC-generating activities such as welding, including activating local exhaust fans; make repairs where necessary. If possible, provide make-up air vents, or continue to open doors when local exhaust is in use.

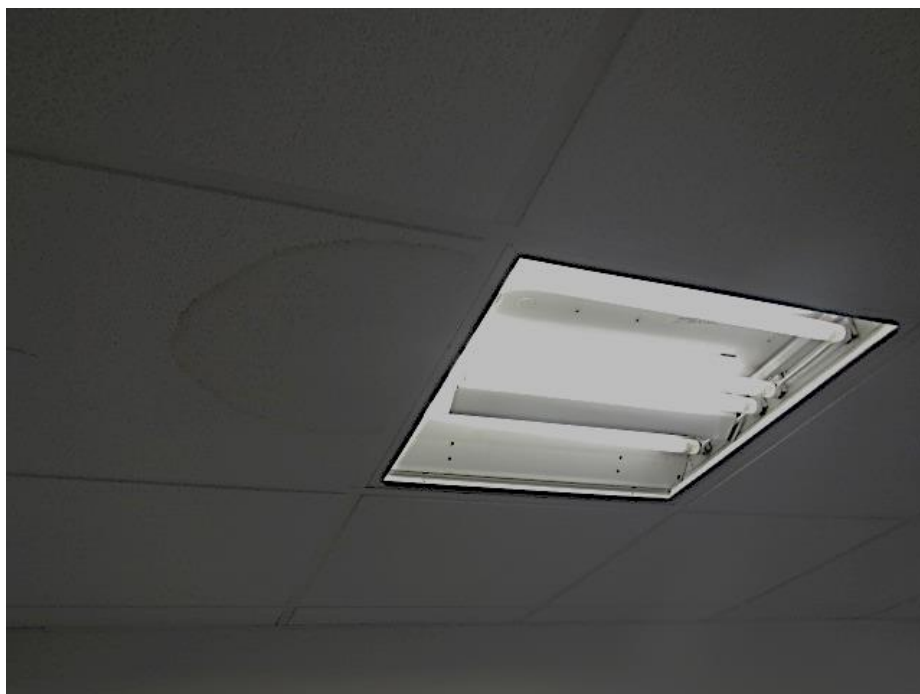
Picture 42

Finally, several areas were missing light covers (Table 1; Picture 42). Modern fluorescent bulbs contain mercury, which can be released if they are accidentally broken.

Missing light covers in office area

15. Replace missing light covers.
16. To address issues related to compliance with OSHA hazardous materials regulations, please contact the Massachusetts Department of Labor Standards OSHA Consultation Program Technical Support, which can be contacted via this link:
<https://www.mass.gov/service-details/osha-consultation-program-technical-support>
